Manhole Inspection Summary

Manhole # S17YY_011MH

Insp Date: **3/2/07 12:54 PM**

Location Address: **3467 COTTAGE AVE**

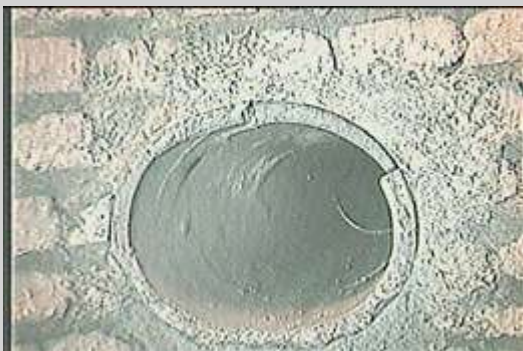
8 in. Circular Gravity Sewer Pipe In @ 2 O'Clock

Pipe Material: **Clay** ☐ Pipe Lined

Invert Depth: **5.90** (ft.) Flow Characteristics: **Fast**

Deposits: ☒ **None** ☐ Mud ☐ Sludge ☐ Debris ☐ Grease

Infiltration: **None** Pipe Seal Cond: **Unknown**

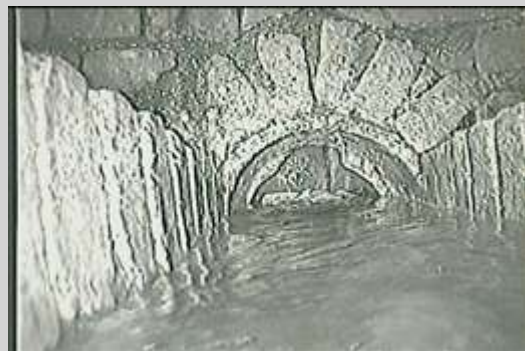
Drop In @ 2 O'Clock

Drop: **Outside** Rod and Bar

Angled: **Yes** Reading: **12.50** (ft.)

Drop Condition: **Open**
